1979 FASTNET RACE INQUIRY

ROYAL YACHTING ASSOCIATION • ROYAL OCEAN RACING CLUB

REPORT

BY
SIR HUGH FORBES SIR MAURICE LAING
LIEUTENANT-COLONEL JAMES MYATT
TO
THE COUNCIL OF THE RYA AND THE COMMITTEE OF THE RORC

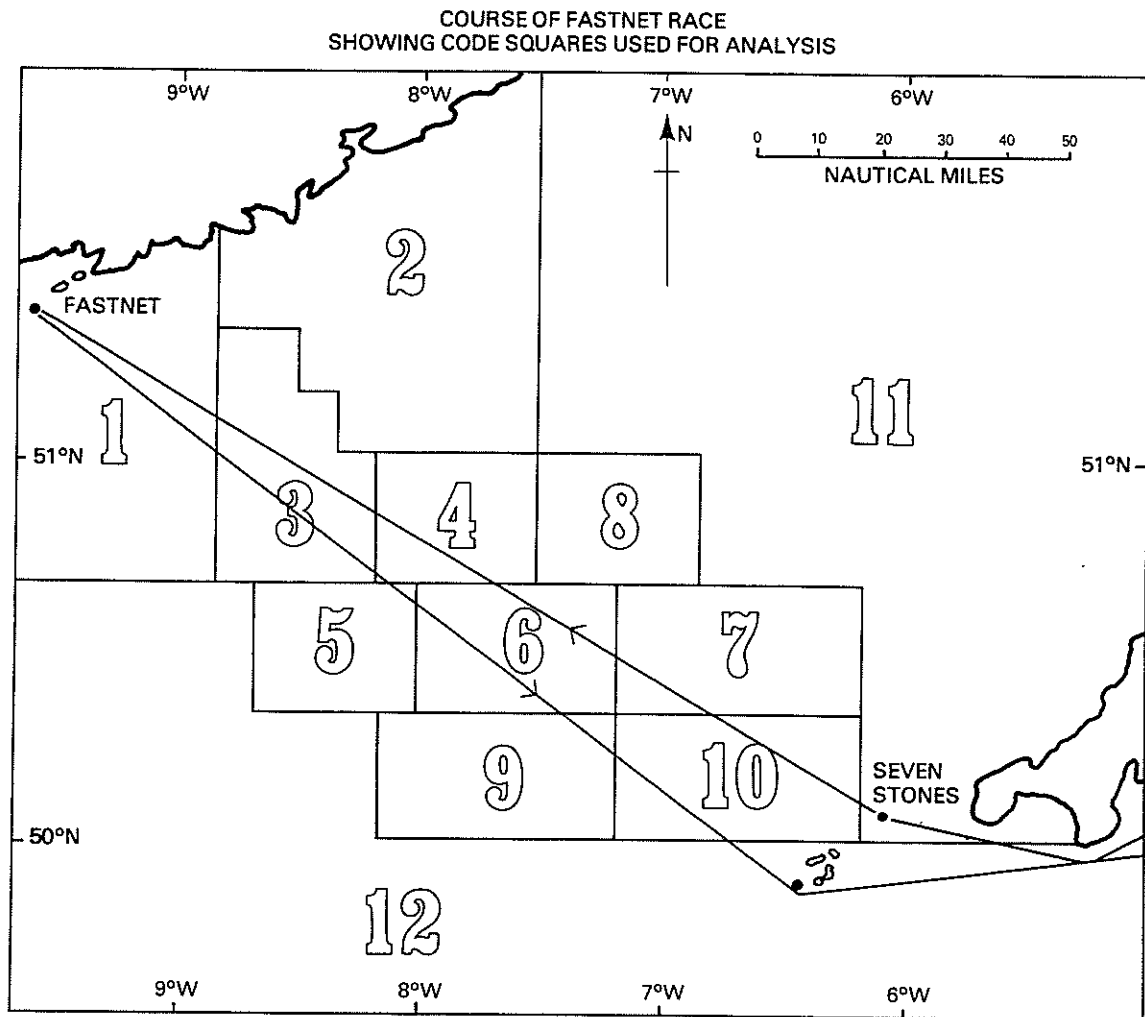
Figure 2.1

- 2.11 As low Y moved across the north of sea area Fastnet there was a marked and rapid wind veer. This resulted in the wind and waves coming from different directions. Those in the vicinity of the Fastnet Rock experienced the veer during the hours of darkness and for them the lack of conformity between wind and sea directions made conditions particularly difficult.

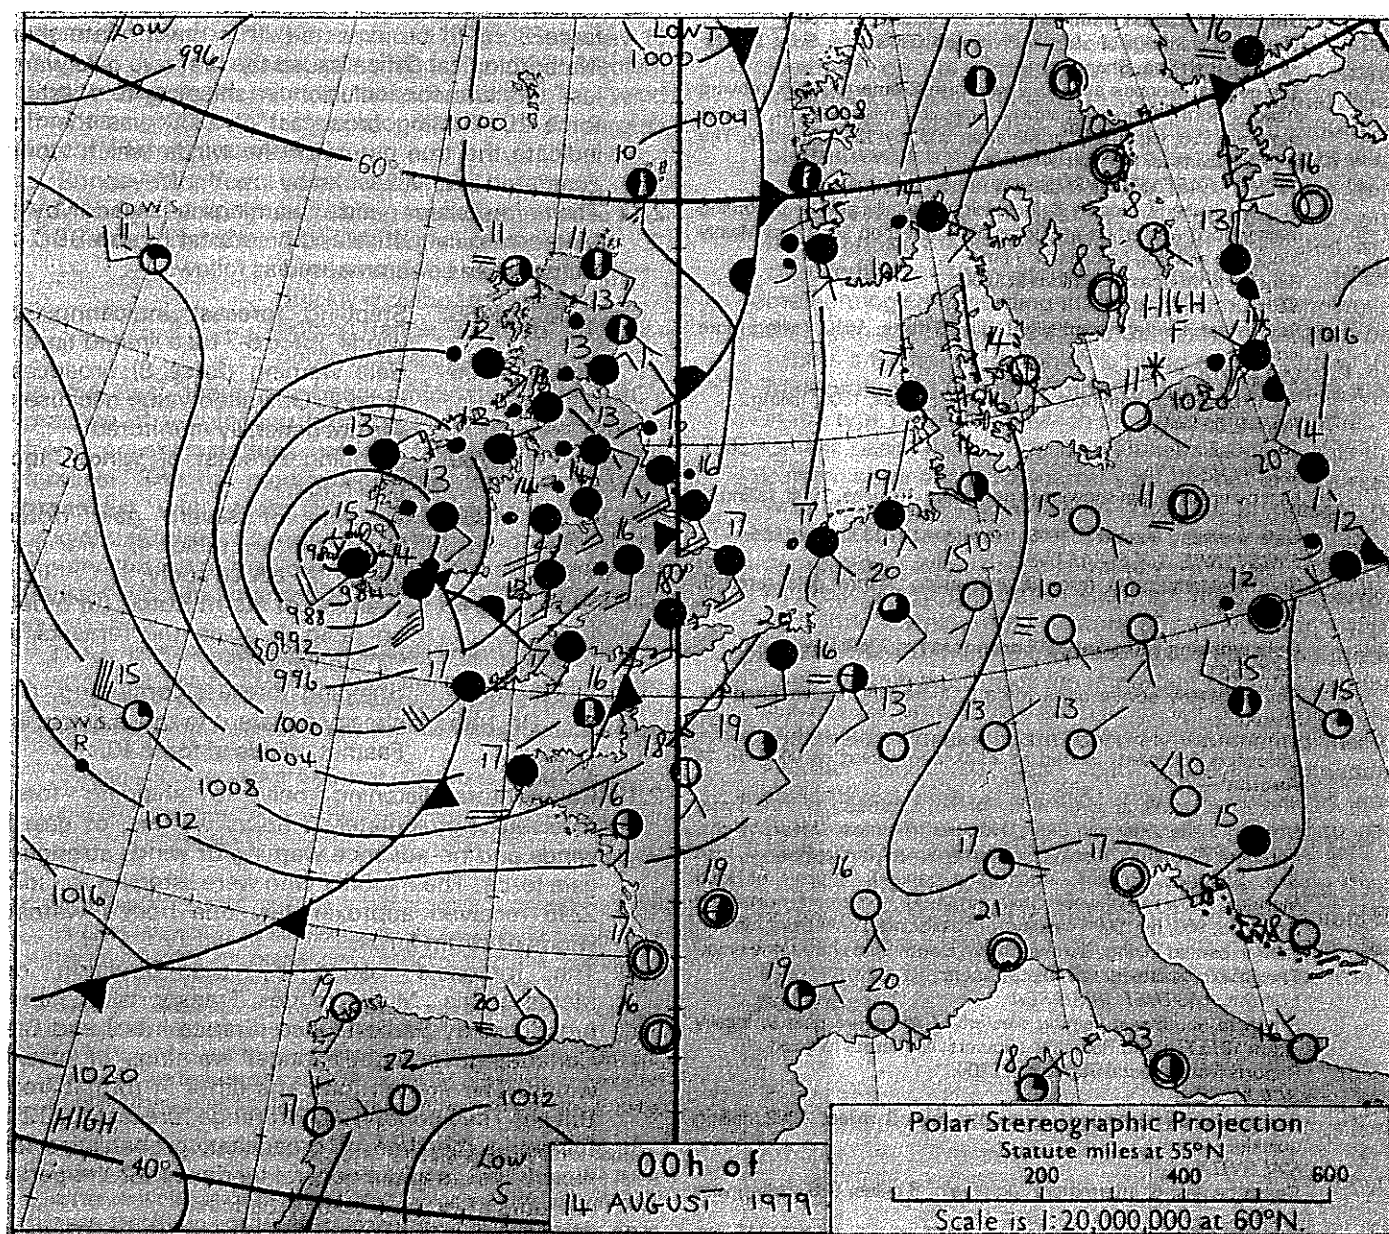
Synoptic Chart at Midnight, 13 August 1979.

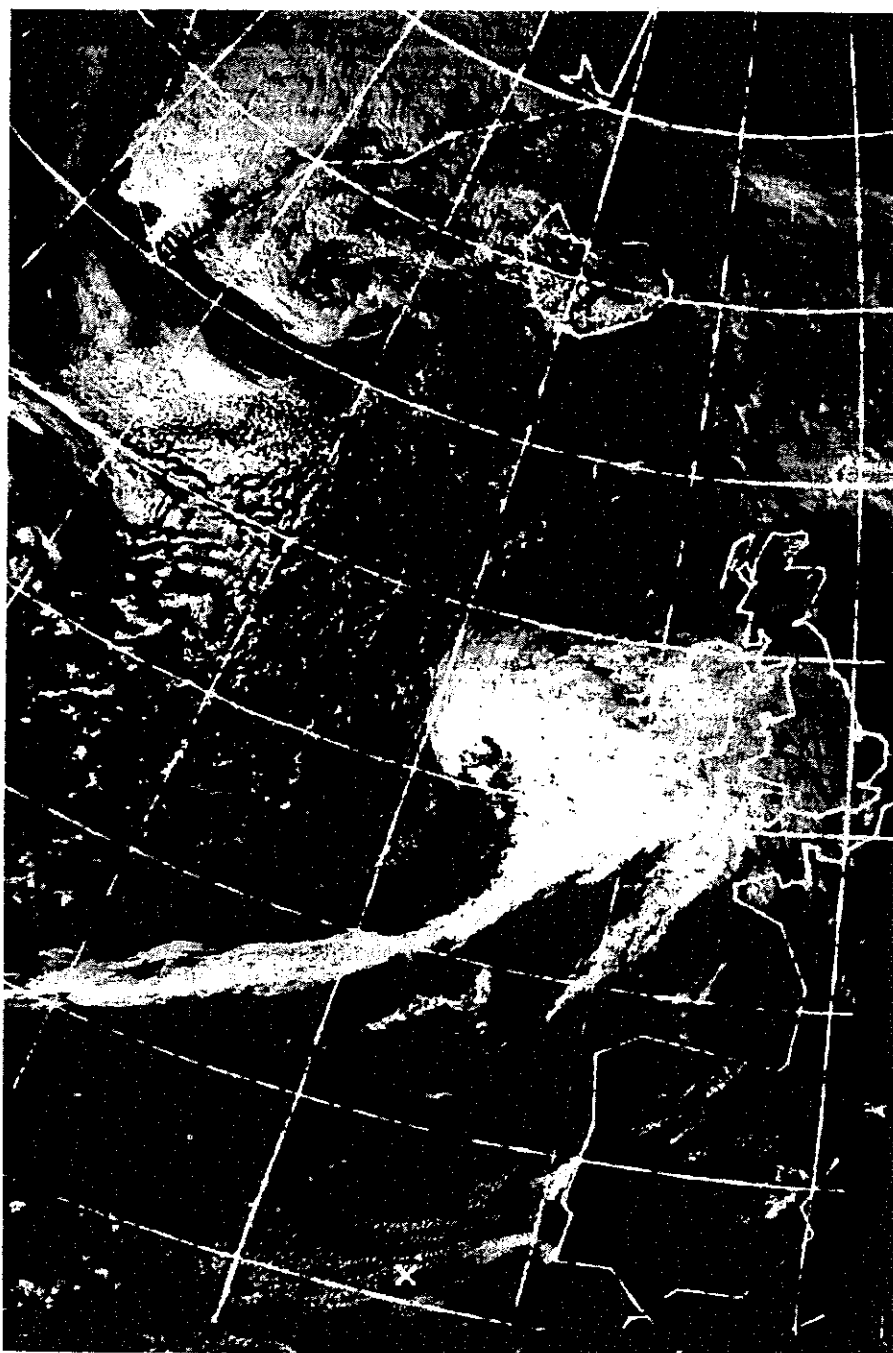
Fig. 3. How the TIROS N satellite saw the Fastnet low at 1637 on Monday. Reference to Fig. 1 will show where the low centre was at this time. The long tail of cloud lies along the cold front while thick cloud covers the centre off Ireland

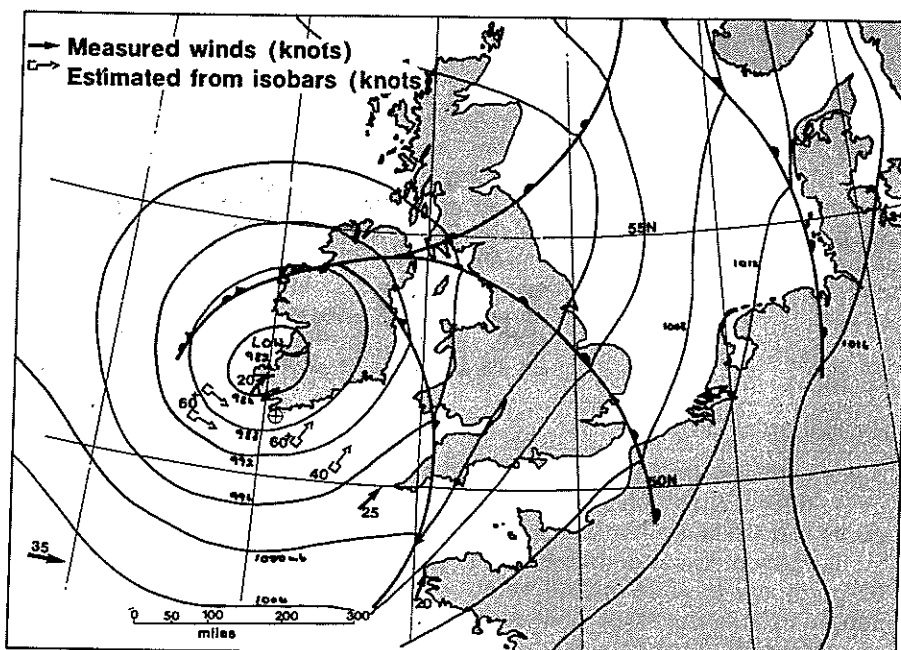
Fig. 5. The storm corridor develops with surface winds above 60 knots off the Fastnet (0100 Tuesday)

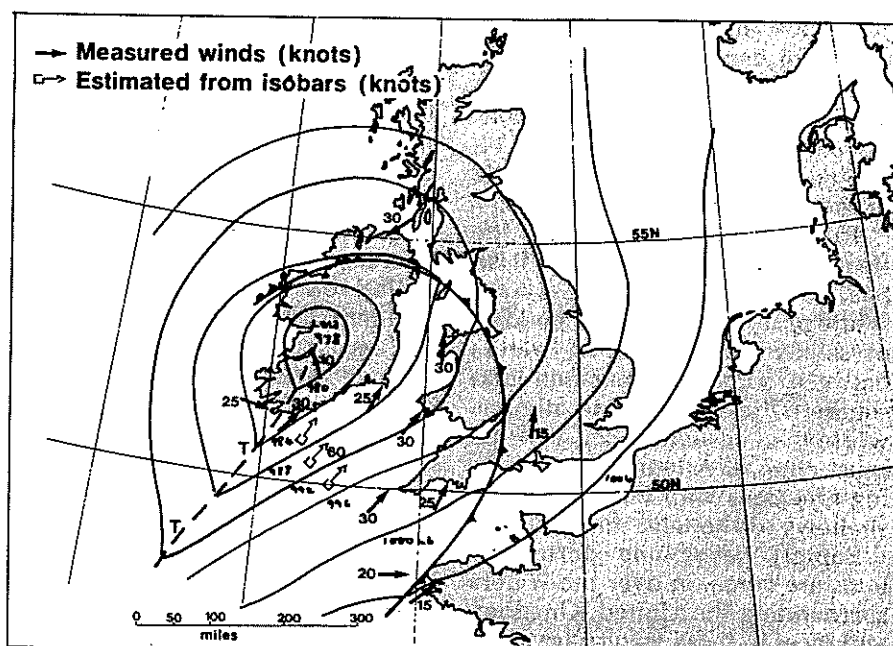
Fig. 6. The height of the storm (0400) when the violent storm-force winds (Force 11) had spread across much of the fleet. All land stations fail to record anything above 30 knots mean speed. A trough-line (T) with a 90° shift on it begins to move across the area

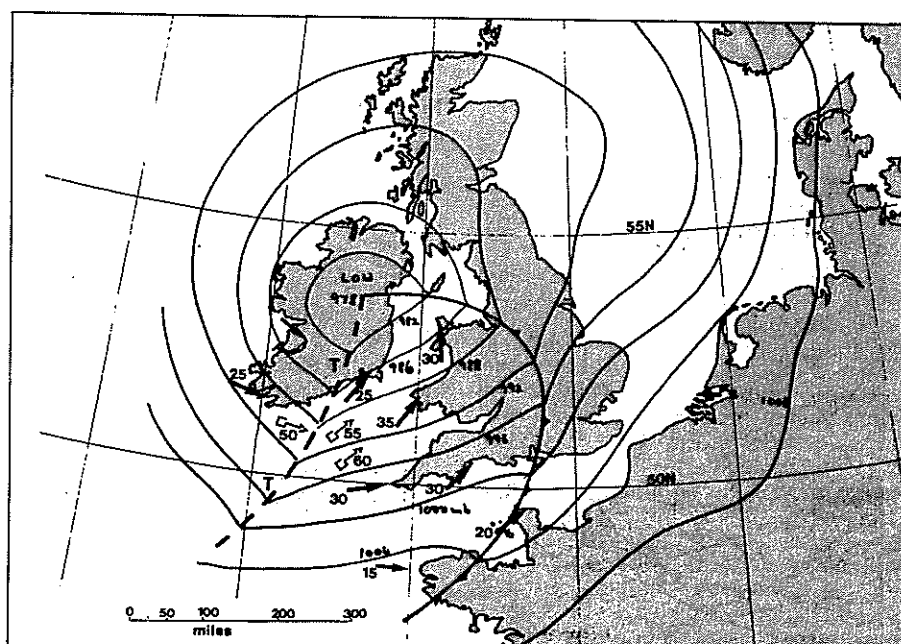
Fig. 7. Off the Rock the wind shifts and relents, but it still blows storm to violent storm force over the rescue operation. The wind drops to Force 10 behind the trough

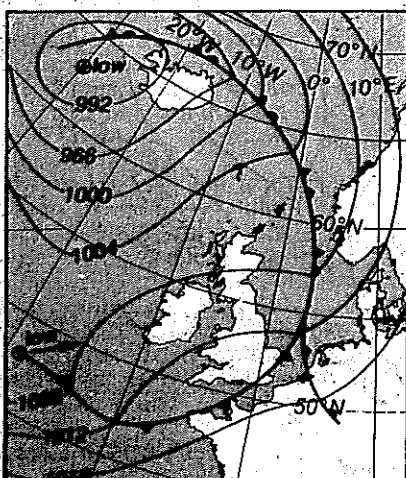
Figure 1: 1200 GMT Monday—
storm center 1007 millibars

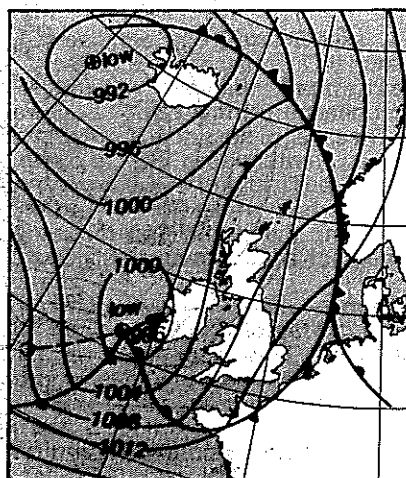
Figure 2: 1800 GMT Monday—
storm center 996 millibars

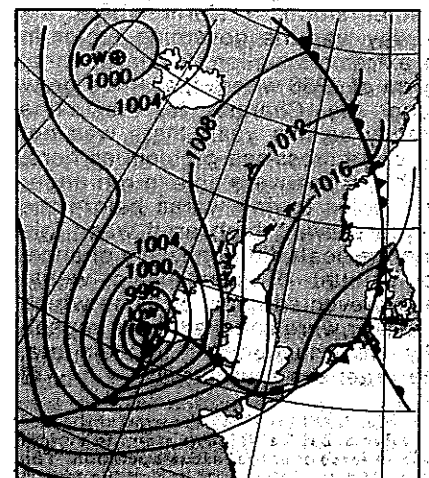
Figure 3: 2100 GMT Monday—
storm center 983 millibars

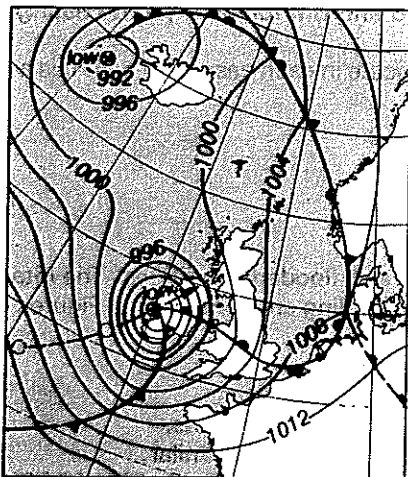
Figure 4: 0000 GMT Tuesday—storm center 979 millibars

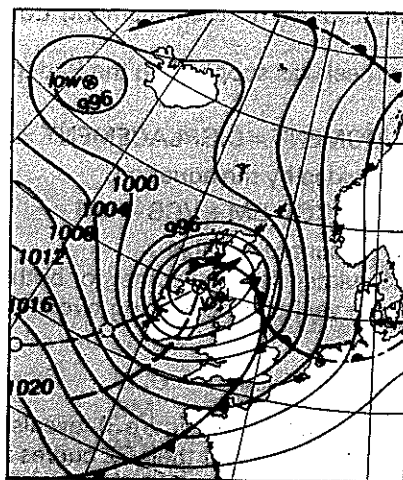
Figure 5: 0600 GMT Tuesday—storm center 983 millibars

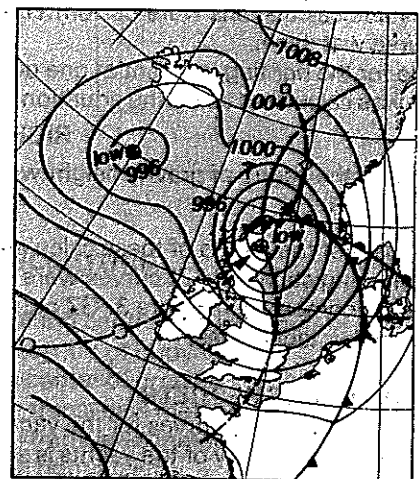
Figure 6: 1200 GMT Tuesday—storm center 983 millibars
