Final Report
Platino Accident
13 June 2016

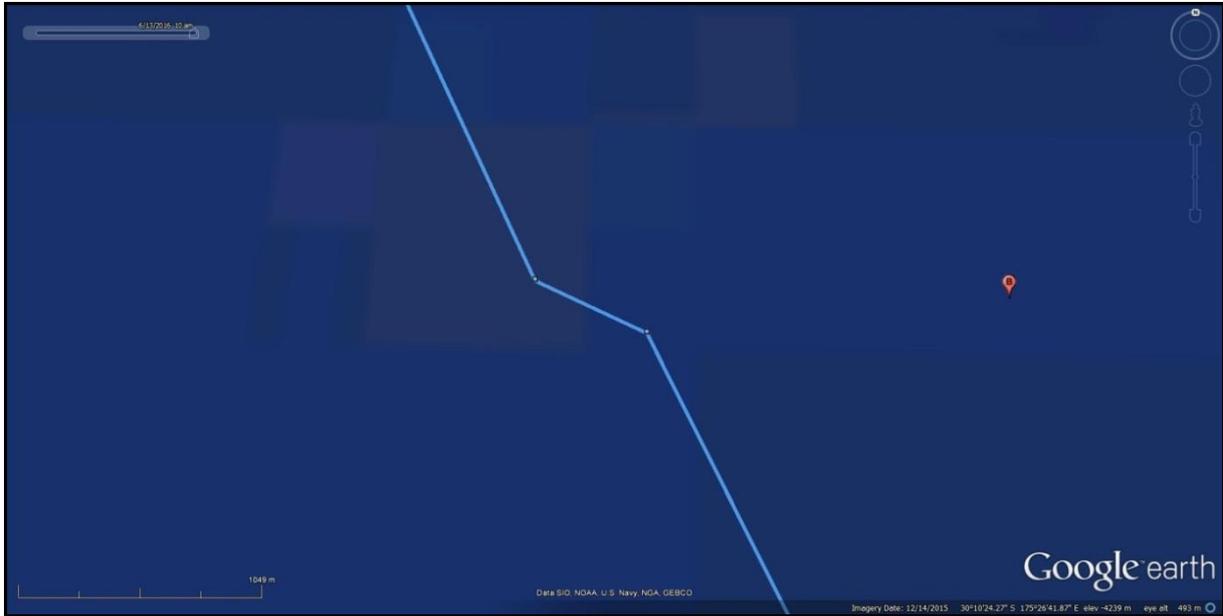
This event occurred 28.8 nautical miles before the position of the accident. The estimated time is approximately 0748 AM or 3 hours, 12 minutes before accident. The track alters from 334° to 295° for 63 metres before returning to 335°. This was a 39° deviation to port for 13 seconds based on an average speed of 9 knots.

Figure 3 Steering event 28.8Nm prior to the crash gybe

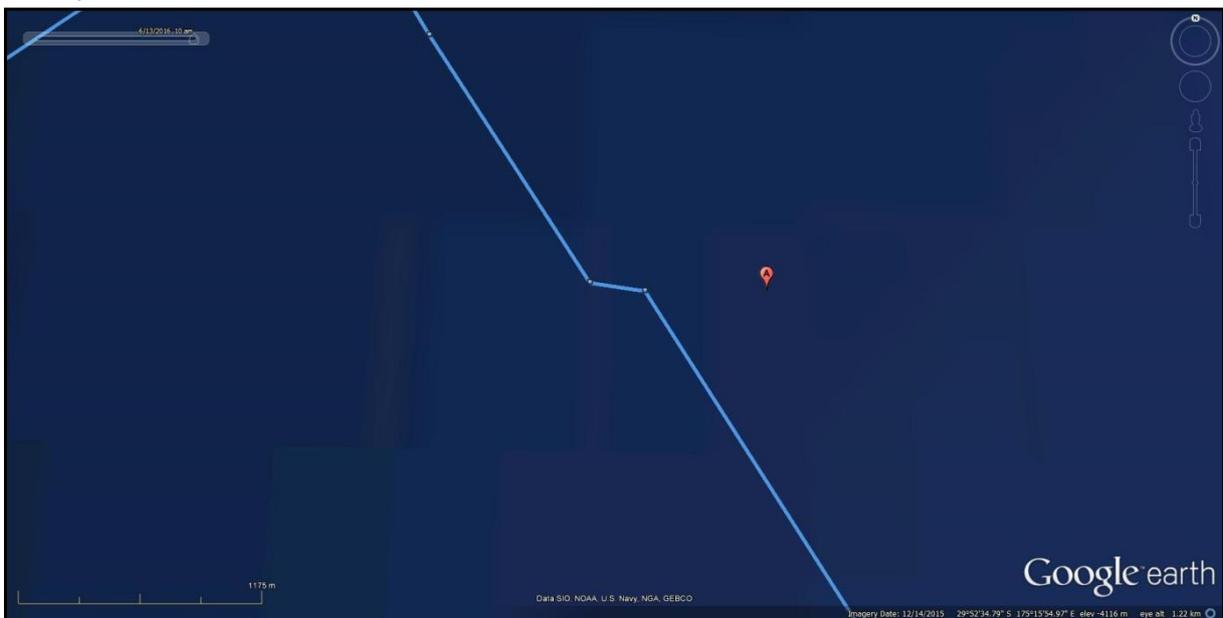
This event occurred 6.9 miles before the position of the accident. The estimated time was approximately 1014 AM or 46 minutes before the accident. The track altered from 328° to 278° for 68 metres before returning to 327°. This was a 50° deviation to port for 15 seconds based on an average boat speed of 9 knots.

Figure 4 Steering event 6.9Nm prior to the crash gybe

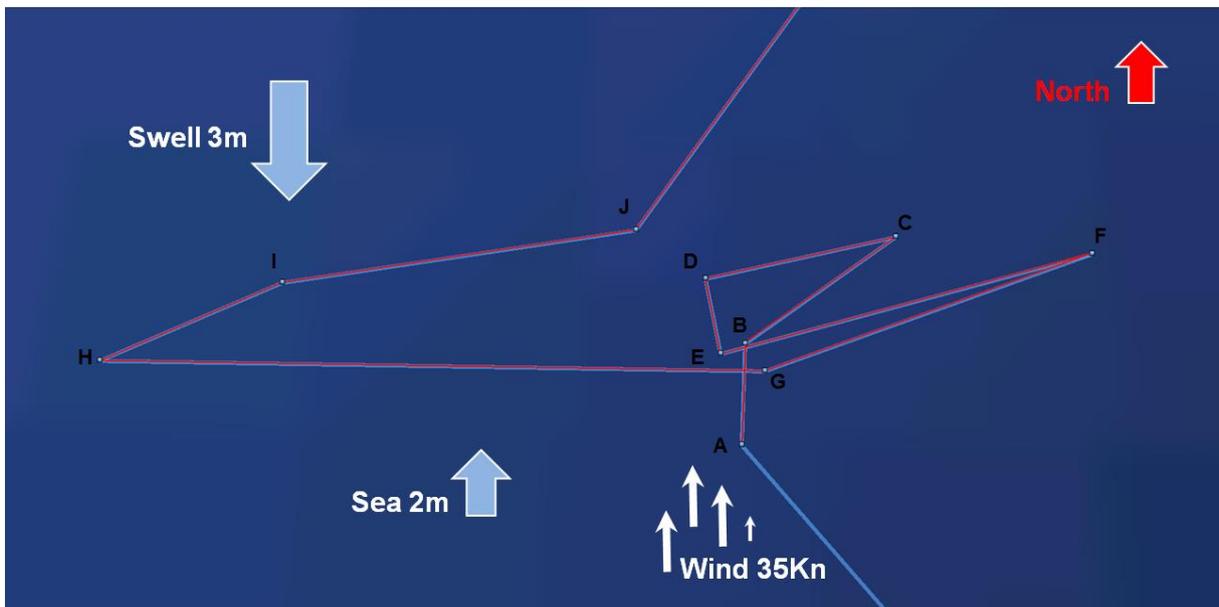
The GPS track information illustrated below shows the path *Platino* followed during the first few minutes of the accident. The yacht travelled along the line from the bottom of the picture and through the series of recorded track points (labelled A to J) before exiting at the top. The initial crash gybe occurred when *Platino* made a significant and unintentional turn to starboard (labelled A) while sailing at approximately nine knots. After this point, the yacht would have slowed, and is likely to have come to a complete stop at times. The distance between the track points was known but the time taken to travel between these could only be estimated based on assumed speed. The actual heading of the yacht was likely to be generally correlated with the path but cannot be assumed to be identical, especially at low speed.

Figure 5 Detailed GPS track information showing *Platino's* path through the accident site

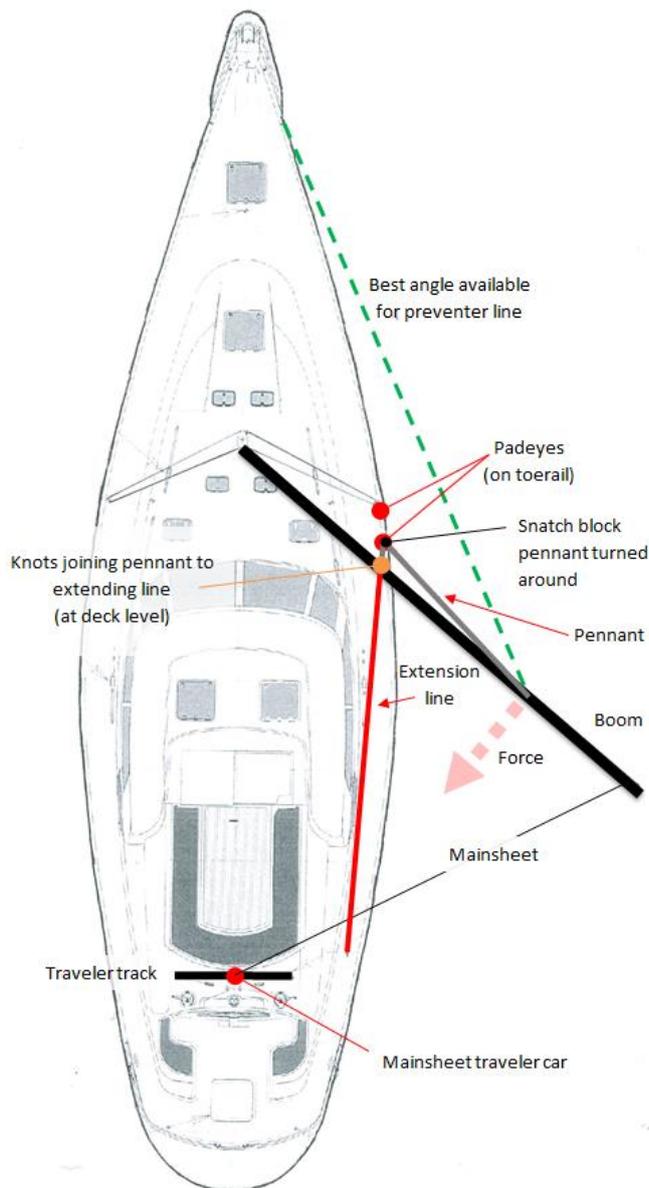
Figure 6 Actual deck plan of *Platino* showing an impression of the preventer rigged by the crew and a more ideal angle for strength

This illustration of the preventer arrangement (above) was created, based on the crew's statements and information gathered during examination of the yacht. The representation was confirmed as accurate by the surviving crewmembers.

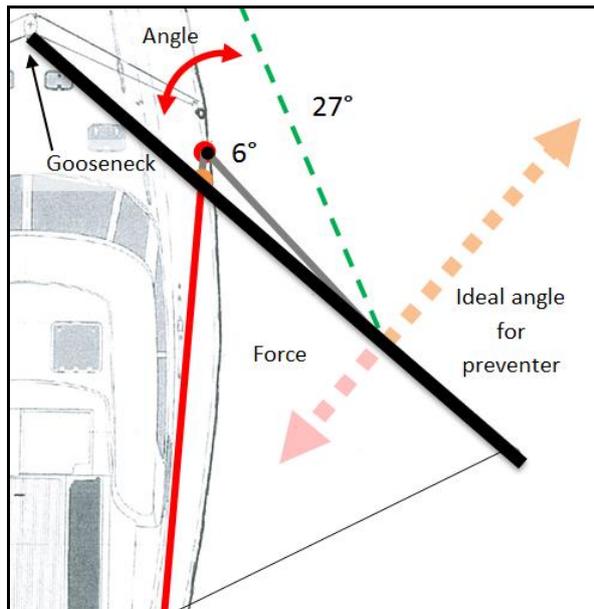
Figure 8 Impression of the preventer arrangements showing approximate angles

The diagram of *Platino's* preventer above shows the approximate angles of a preventer line led forward to the bow (the best case scenario) and the actual arrangement of the preventer rigged by the crew.

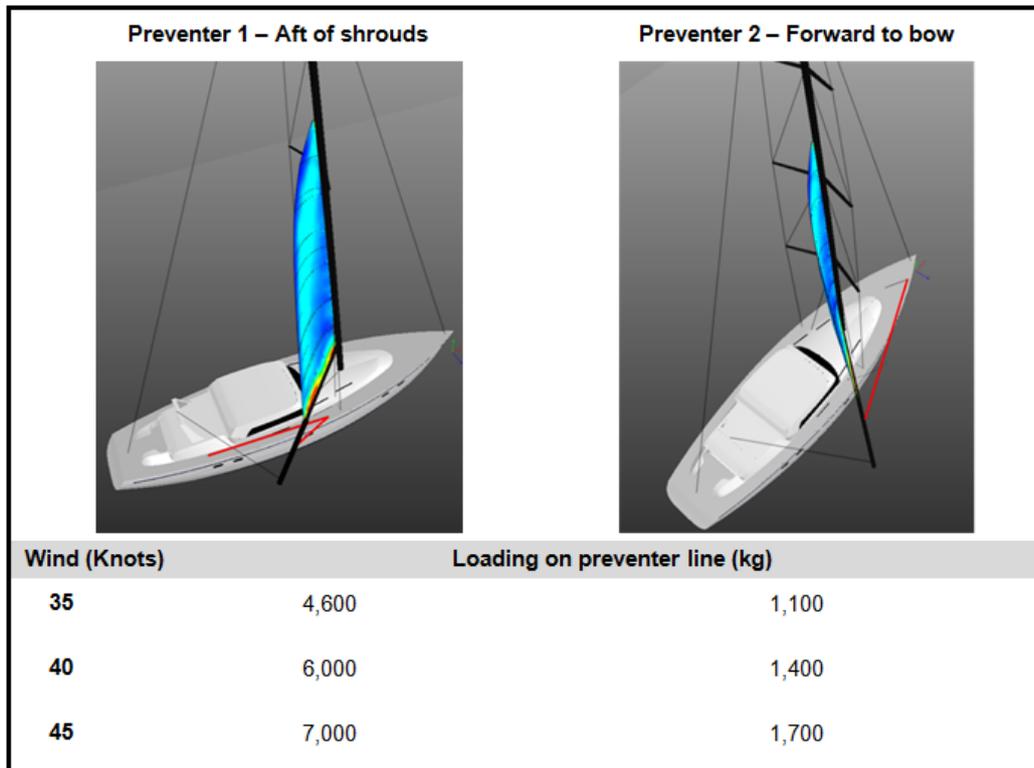
Figure 9 Computer simulation showing calculated preventer loads based on scenarios provided by this investigation

In the simulation above, Preventer 1 represents the actual arrangement rigged by the crew, which was anchored on the padeye fixed to the toe rail aft of the shrouds. Preventer 2 represents the best case scenario of leading the line as far forward on the bow as possible.

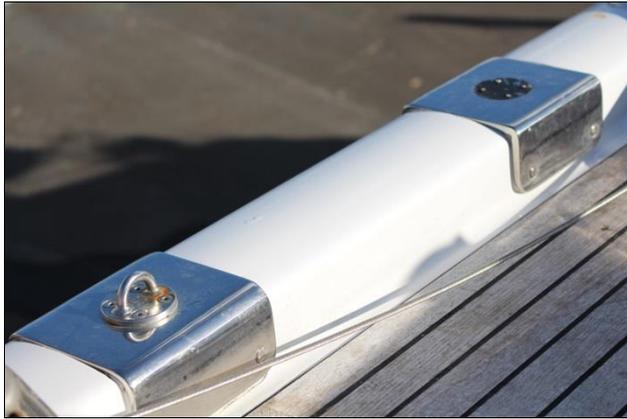
Figure 10 Starboard toerail showing padeyes

This photo shows the saddles and padeyes that were fitted to the starboard toerail during the refit. Note the after-most of the two padeyes (right) is missing from the saddle

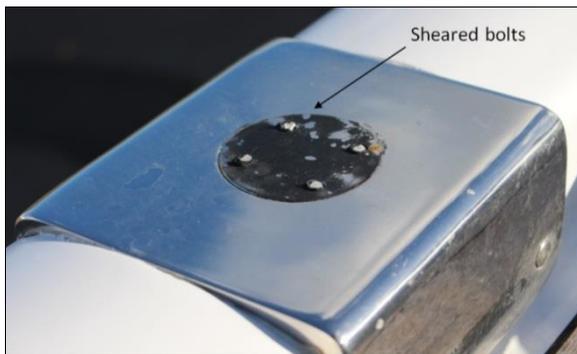
The next weakest part of the preventer was the padeye on the toerail, with a breaking load of 4,080kg. The four 6mm stainless steel bolts used to secure the padeye to the saddle on the toe rail sheared through the thread, when the knots tied in the preventer line became stopped off against the snatch block.

Figure 11 Starboard aft toerail saddle, sheered padeye

The 57mm padeye used to anchor the preventer was one of four fitted to the toe rails during the refit. The padeyes were placed at the recommendation of the sail supplier and were intended to be used for outboard sheeting of the jib³⁵. The padeyes were not intended to be used to anchor a preventer, which was likely to involve substantially higher loads. Despite the relatively lower loads expected for outboard jib sheeting, the sail supplier recommended padeyes with a safe working load of four tons be used. Based on this, 76mm padeyes with a safe working load of 4,705kg and a breaking load of 9,430kg were selected. These would have allowed a substantial safety margin for the intended purpose. The 76mm padeyes specified have more than double the strength of the 57mm padeyes that were fitted.

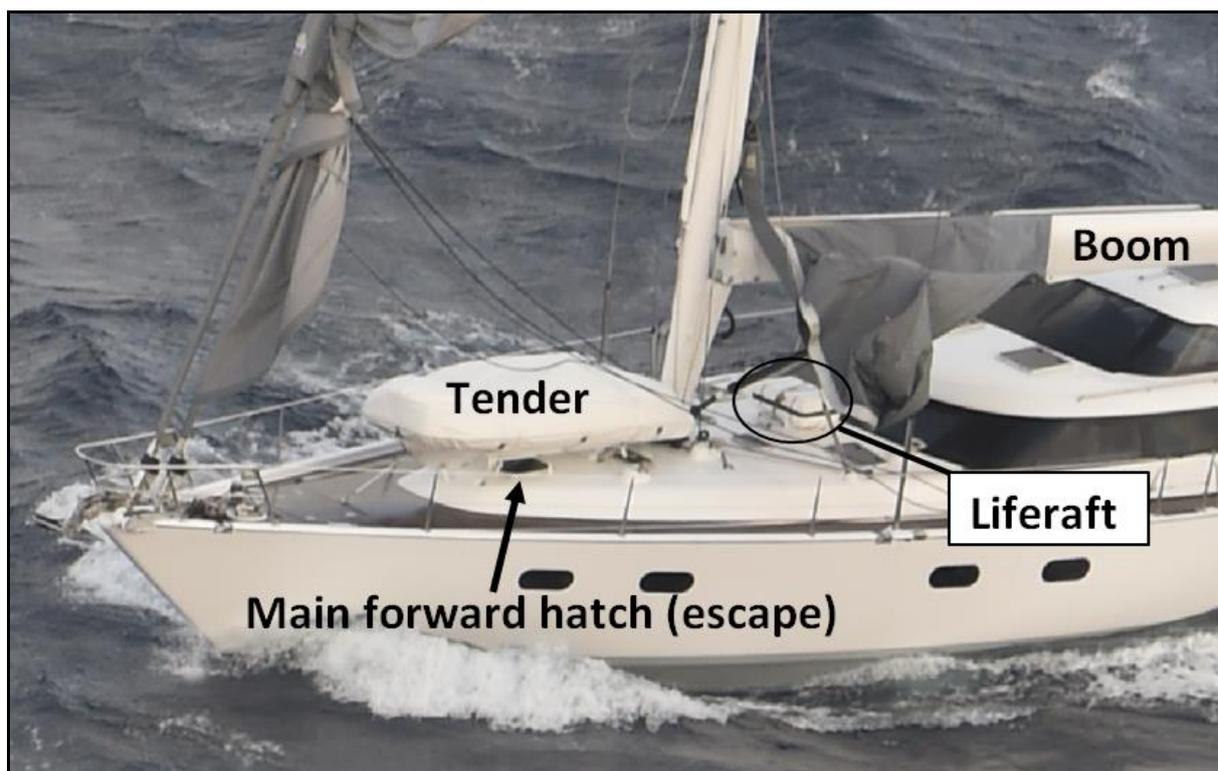
Figure 15 *Platino* 13 June following the initial crash gybes.

In the first few minutes that followed the initial crash gybe, *Platino's* jib (headsail) and sheets were flogging uncontrollably over the foredeck area. No adjustments were made to the jib and it may have rendered the foredeck inaccessible to the crew until the sail disintegrated sometime later. The boom's repeated impacts on the shrouds also had the potential to topple the mast at any time and any crewmember on the bow would have been completely exposed.

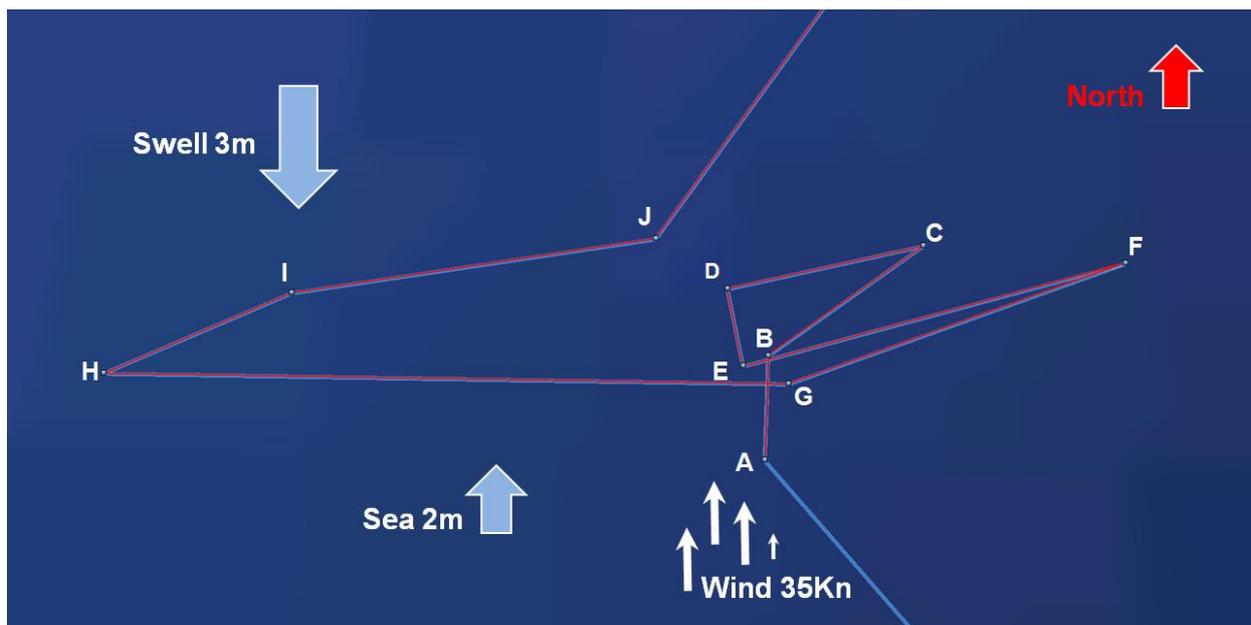
Track data points recorded previous to the event below are evenly spaced and show a consistent path, generally with very little variance. The track shown below shows a dramatic change in the yachts behavior and indicates the path the yacht travelled through the scene of the accident. The first uncontrolled gybe is known to have occurred at approximately 1100 AM on 13 June 2016 and was caused by a substantial turn to starboard.

Figure 17 GPS track information from accident site, wind and sea information added.

The picture above shows 10 distinct alterations in the direction of *Platino's* path, which are labeled A to J. The distance between the track points is known but the time taken to travel between these can only be estimated based on assumed speed. The actual heading of the yacht is likely to be generally correlated with the path but cannot be assumed to be identical.
