**REPORT OF INVESTIGATION  
INTO THE CAPSIZE OF  
YACHT 'RAMBLER 100'  
OFF THE CORK COAST  
ON  
15th AUGUST 2011**

**REPORT No. MCIB/206  
(No.9 of 2012)**

Report MCIB/206 published by The Marine Casualty Investigation Board  
Printed 19th October 2012.

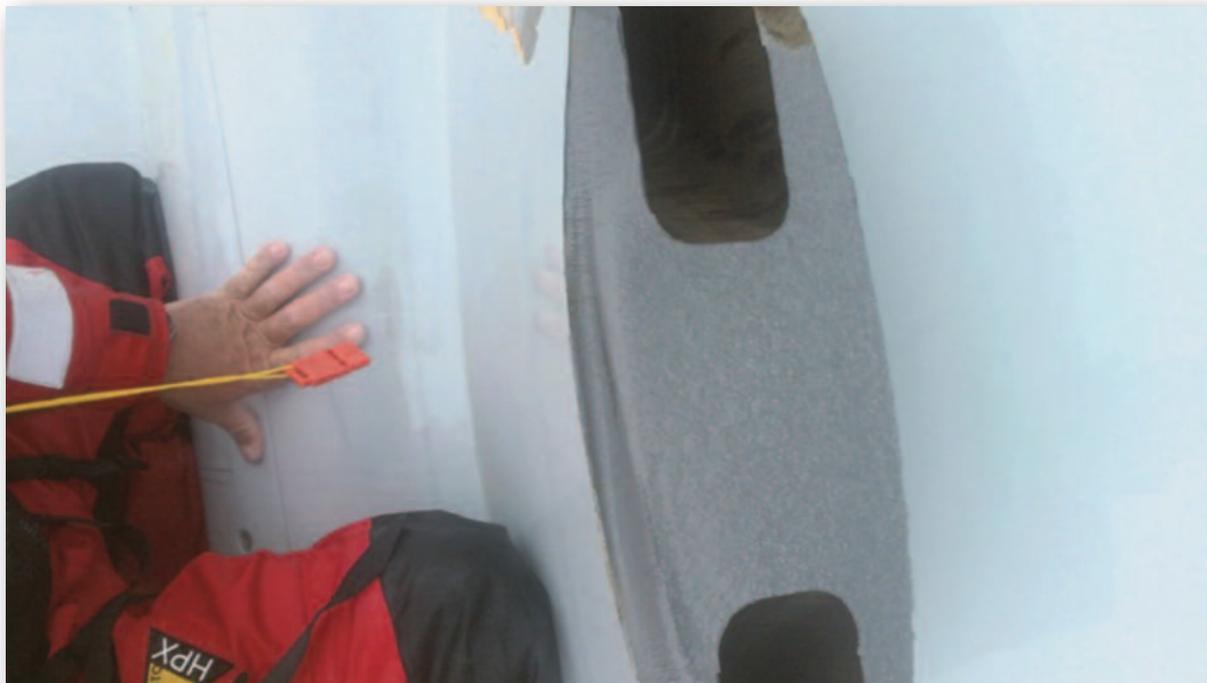
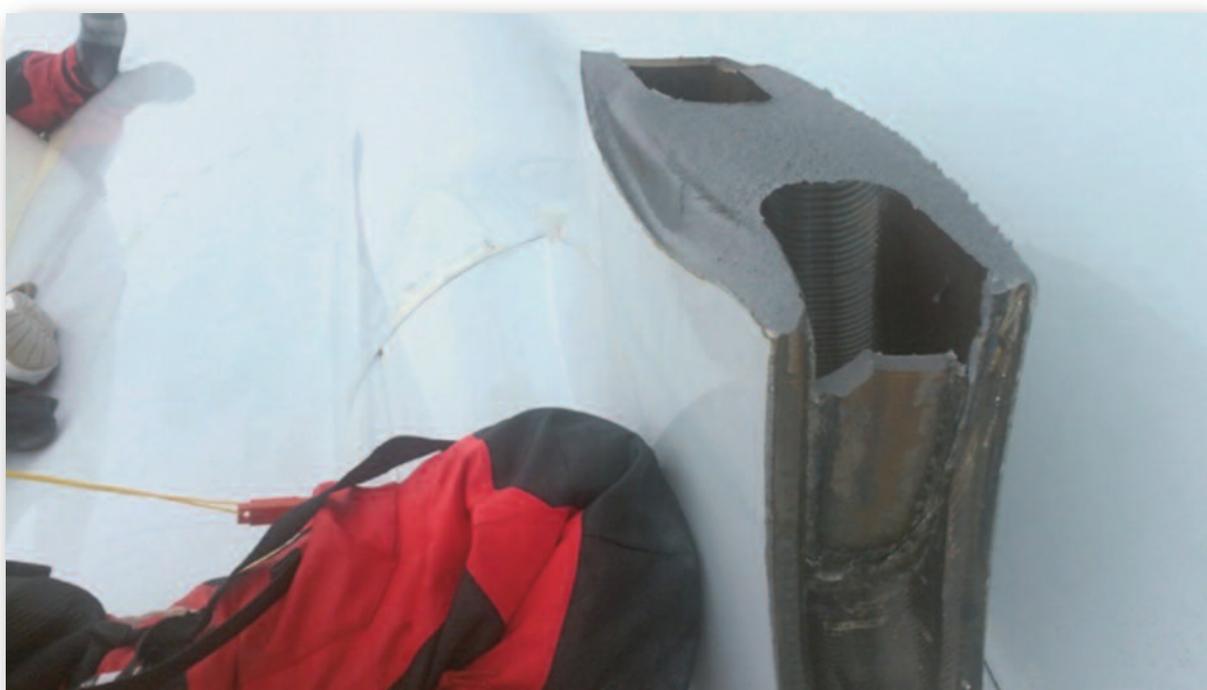
- 1.4 It soon became apparent that the keel fin had fractured and the major portion of it had become detached.
- 1.5 The Valentia Coast Guard and Baltimore lifeboat commenced search and rescue operations and all 21 crew members were picked up, the 16 on the hull by the Baltimore lifeboat and the 5 in the water by the 'Wave Chieftain', a dive boat chartered by another race competitor to take photographs as they rounded the Fastnet Rock. One crew member, Ms. Wendy Touton who had been in the water, was suffering from hypothermia and was airlifted by Coast Guard helicopter R115 and taken to Tralee General Hospital, all other crew were taken to Baltimore, Co. Cork.

- 5.1 The failure of the keel was both dramatic and catastrophic causing the rapid heeling and subsequent capsizing of the yacht '*Rambler 100*'. The reasons for the failure are not discussed in this report as the analysis of the keel stub has yet to be completed and the causes of the failure have yet to be determined.

Appendix 7.4 Photos of 'Rambler 100' Inverted showing Failed Keel Stub.

- 6.8 It is recommended that the flag State authorities should instigate an investigation as to why the keel failed and disseminate any recommendations/technical guidance following this investigation.

- 6.9 It is recommended that yachts racing under category Mo1 be required to carry their AIS antenna at mast head to facilitate stronger AIS signals.
- 6.10 It is recommended that the ISAF in conjunction with the RORC and the major yacht racing national authorities develop regulations concerning the standard of welded keel fins.

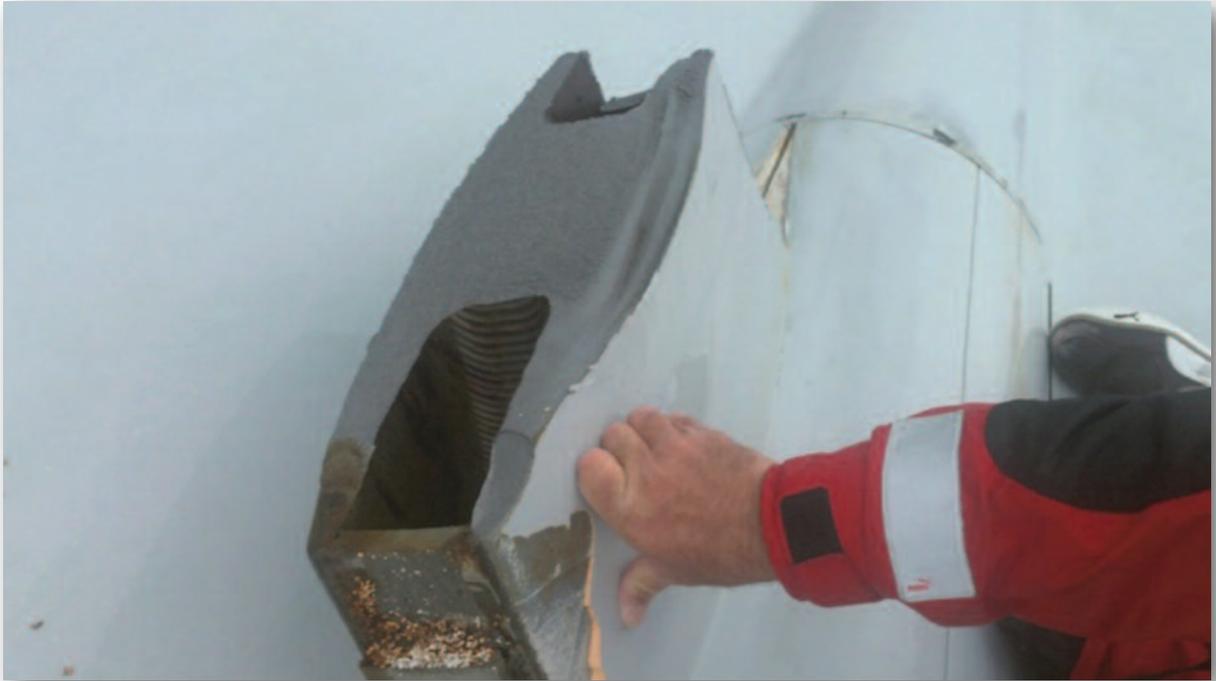
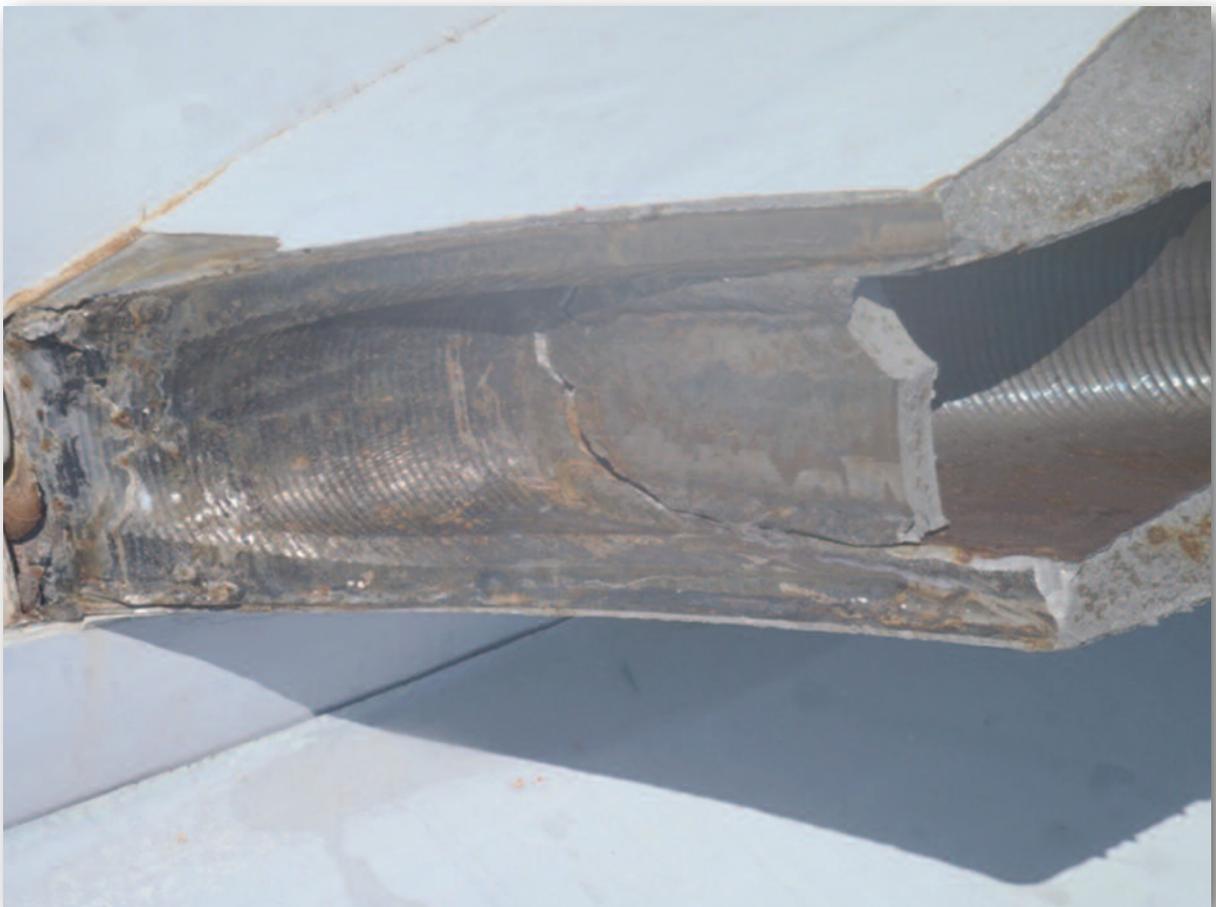
Appendix 7.4 Photos of 'Rambler 100' Inverted showing Failed Keel Stub.

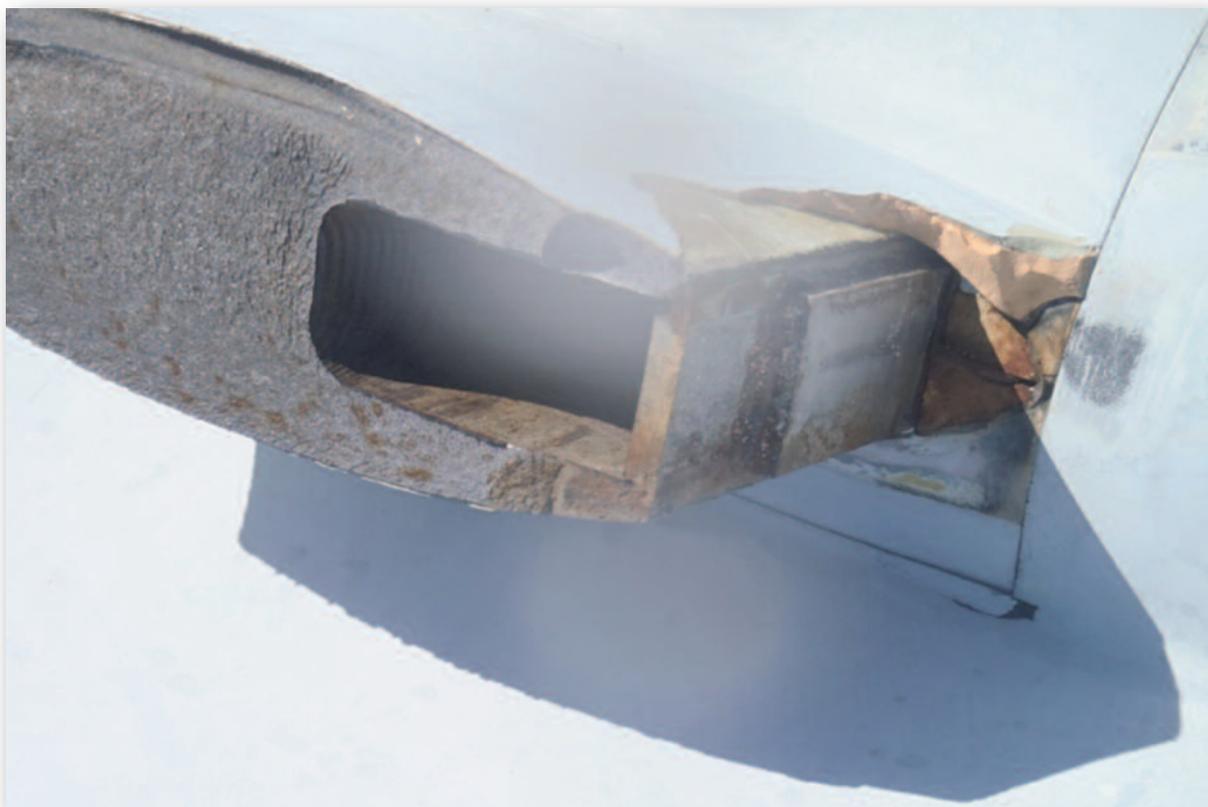
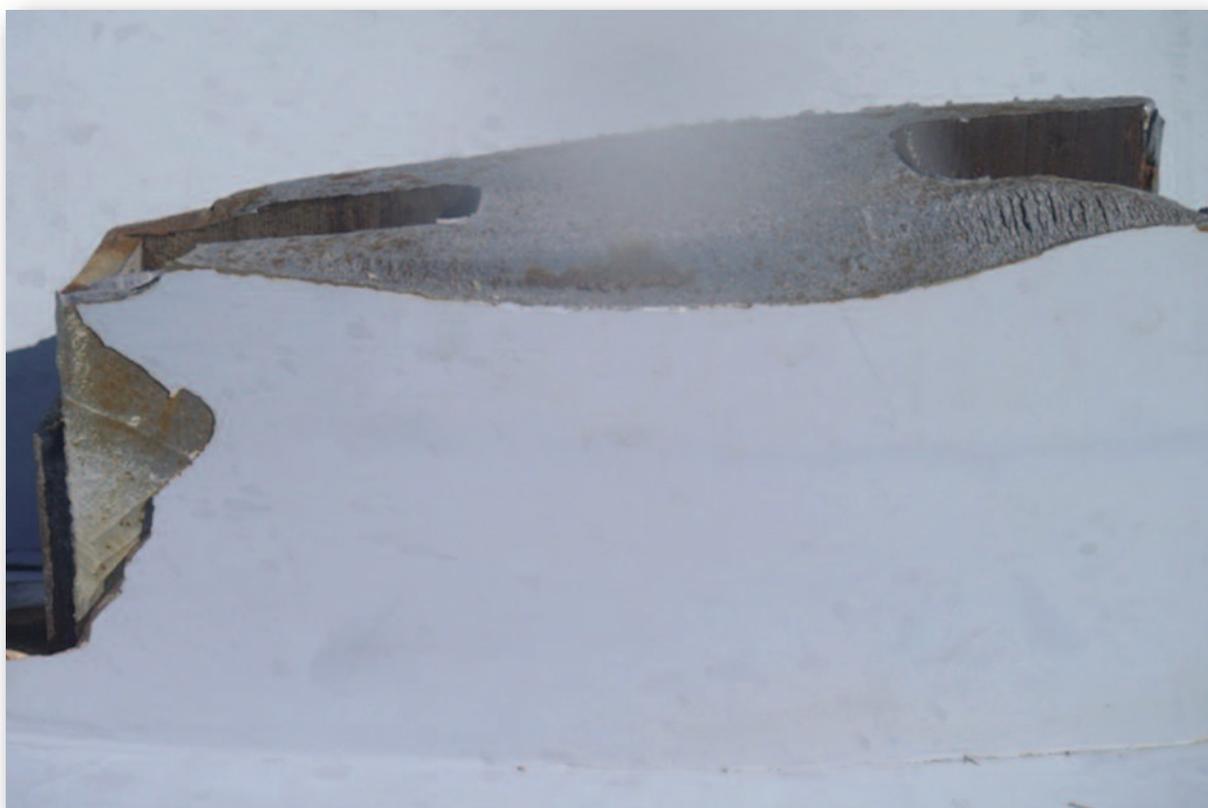
Appendix 7.4 Photos of 'Rambler 100' Inverted showing Failed Keel Stub.

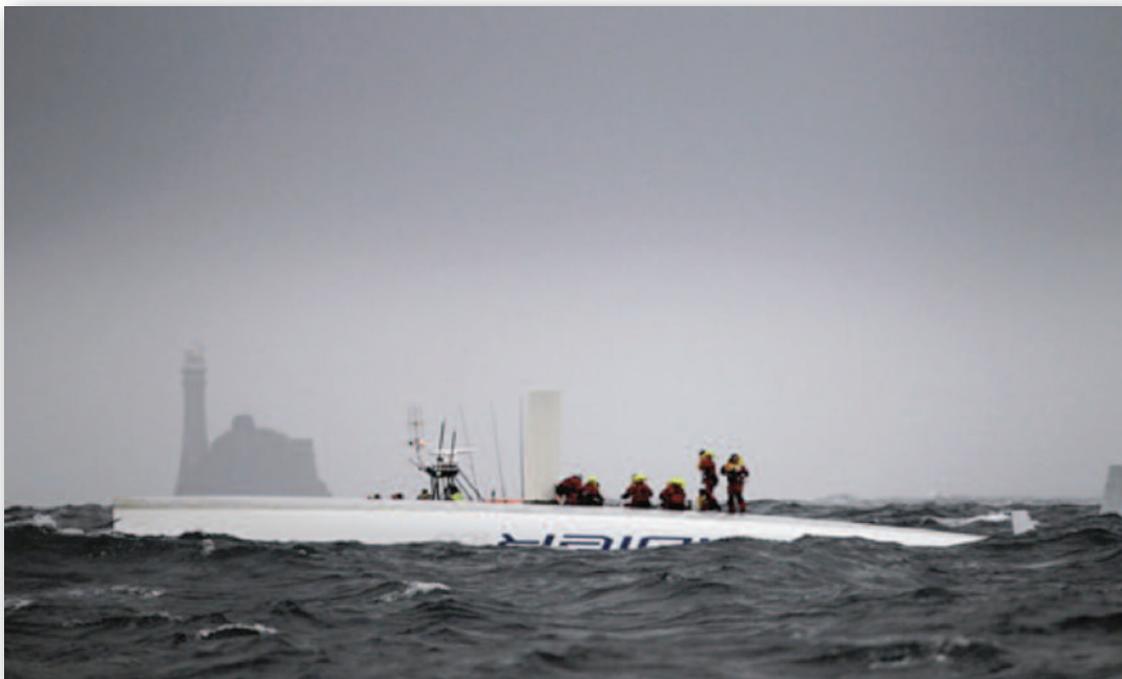
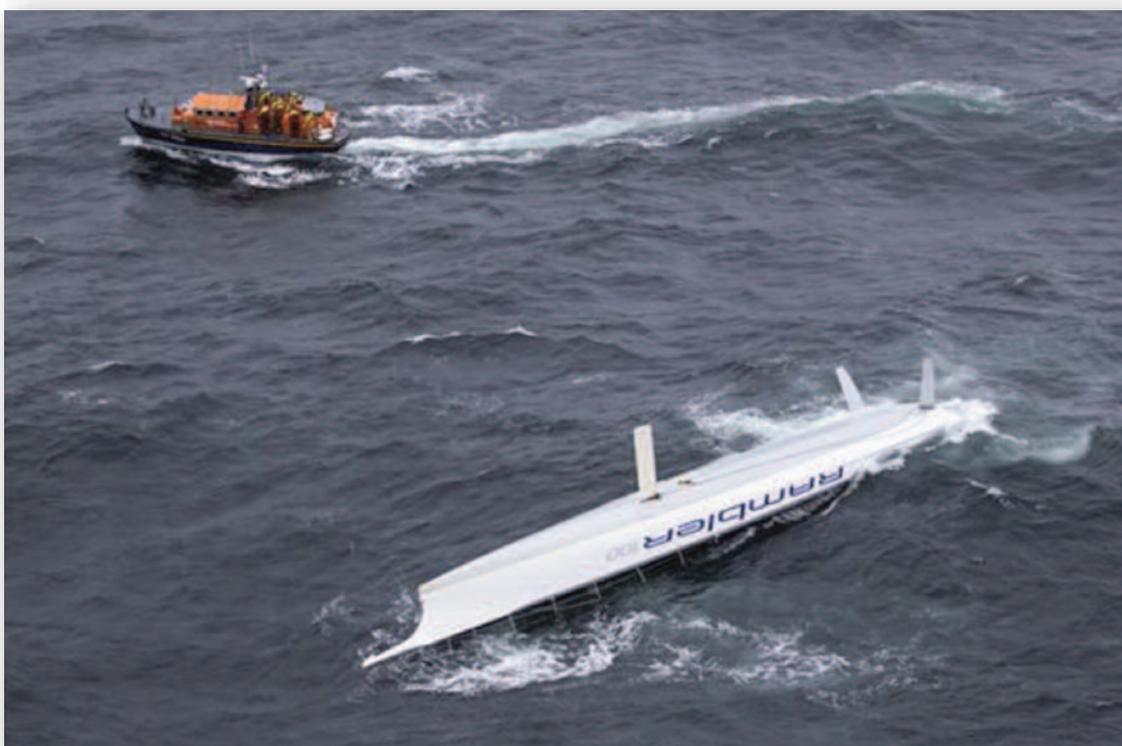
- 5.8 The RNLI lifeboat crew found it difficult to see the upturned hull of *'Rambler 100'* until they were within a few hundred metres of the vessel due to the poor visibility at the time. Had the underwater appendages been painted with a bright colour, they would have been visible from a much greater distance.

Appendix 7.6 Photos of 'Rambler 100' Inverted following Capsize.
