Patriot rudder loss 2018 Sydney to Hobart case study

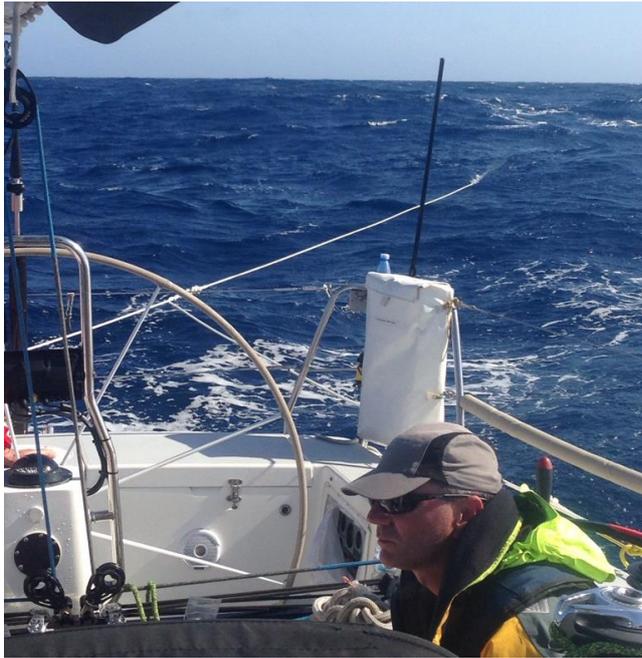
Eventually playing around with sails we managed to pull tight against the drogue and then started tracking straight under jib alone. The danger from the boom was seen to be too great and the boat wouldn't track so the main had been already dropped. We had plenty of diesel so it was decided to motor sail slowly. We were concerned at the time about the thickness of the warp so kept speed to around 3 knots (which later under tow proved we could have gone faster but at the time we were being cautious). In hindsight we should have tried trysail as well for additional balance and a little more speed. The shape of the hull and length of sheets meant the effect of going to beam max was negated as the sheets ran next to the aft cleats anyway.

It was difficult to track straight with the yacht hunting to port and starboard, although some adjustment of sheets and sails got it going straighter. Unfortunately, not having a swivel shackle at the bridle end meant we got bad twisting which effectively shortened the bridle and increased the poor tracking. We settled in to a slow and steady 3 knots heading towards land but relayed to the navigators that we could not go to windward, only reach. This information was provided to the navigator and skipper who determined an initial plan to head to the safe waters of Jervis Bay, later changed to Ulladulla due to facilities there. Lesson learnt, pre-plan safe havens to match the yacht's draught.

- Ideally have a dedicated emergency tiller and rudder box setup on the stern – wouldn't want to be on a lee shore with drogue steering
- Longer sheets and definitely a swivel at the bridle end of the warp. Weight of chain and swivel at drogue end saw the drogue sit well 2 wave lengths back from the boat. Warp and drogue size was right for the boat, a thicker warp would have been comforting though.
- 3 knots is about all you can do safely under drogue steering we noted. Current and moderate winds meant we couldn't go to windward.
- Without the drogue we wouldn't have been able to be towed.
- A dedicated towing bridle setup with full chafe protection is a must, ideally load shared to winches.
- Pre-plan safe havens before heading out, particularly those which cater to deeper draught vessels and understand available facilities.

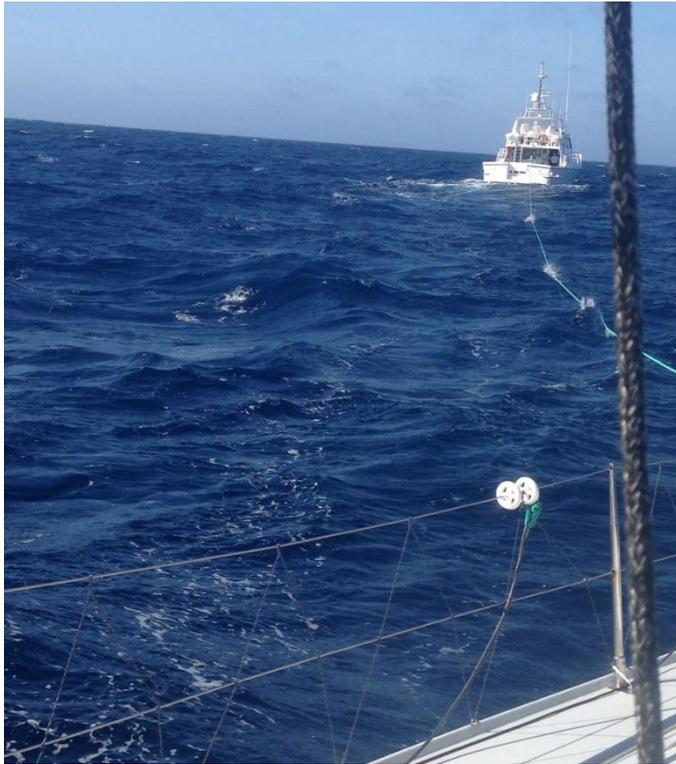
Early the following morning a Marine Police boat arrived to tow us in. The skipper accepted a tow, so we set up a towing bridle onto bow cleats through the fair leads. The Police boat initially went approximately 9 knots which was way too fast, with the yacht hunting dramatically. It was quite uncomfortable and led to the shearing of the fair lead on Port side and snapping of the bridal rope. Lesson learnt – don't use fair leads and keep the speed down, perhaps re-rig to mid aft instead of drogue bridle. We re-tied the towing bridle, doubling up the rope and added chafe protection around the forestay and adding load sharing ropes back to the primary winches and resumed at around 5 knots. Lesson learnt – we should have had a better dedicated towing bridle with chafe protection rather than rely on thick mooring lines. Also even Police boats often don't know the best setup, fortunately we had on board an experienced ex Police current Port Phillip sea pilot skipper who had himself towed many boats in the heads, so he determined the best approach. The revised setup worked well and was used the whole way in, we settled to 5k approx. speed, even then we moved around a lot. See <https://youtu.be/xEgMMtm3rd4> to watch how the yacht behaved under tow.
