Final Report
Platino Accident
13 June 2016

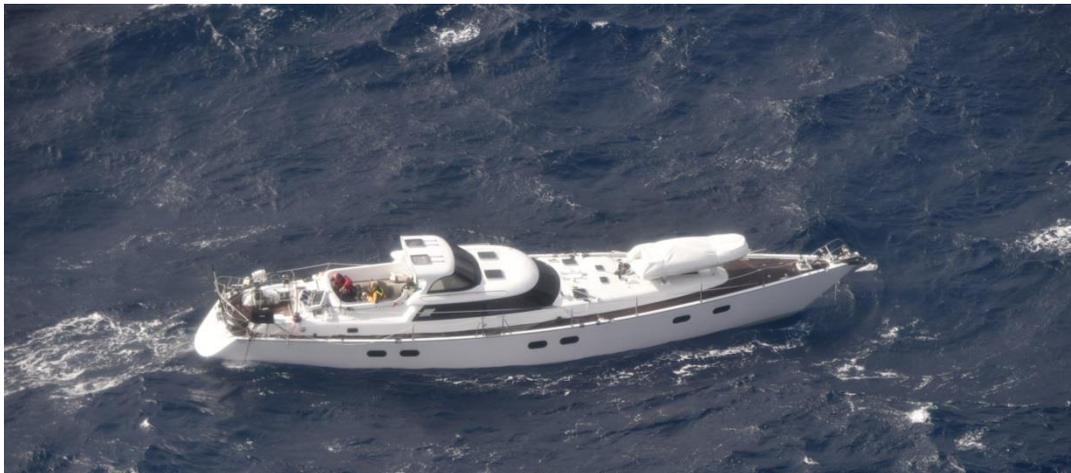
The yacht **Platino** departed New Zealand on Saturday 11 June bound for Fiji with a crew of 5. On the morning of Monday 13 June the crew lost control of the yacht while sailing on a broad reach, 305 Nm NNE of Cape Reinga. In the initial moments of the accident, the boom swung across the stern of the yacht and rigging associated with it struck a crewmember, fatally injuring him. The mainsheet then broke free from the deck and the boom continued to swing, quickly causing substantial damage to the rear of the yacht. Another crewmember was lost overboard seconds after the initial turn and the remaining crew were unable to bring the boom or the yacht under control, or to rescue him. Though some control was eventually regained over the yacht, the boom was never restrained and continued to damage the rigging until the mast collapsed later that day.

Figure 1 Tuesday 14 July – **Platino** with surviving crew waiting in cockpit prior to rescue

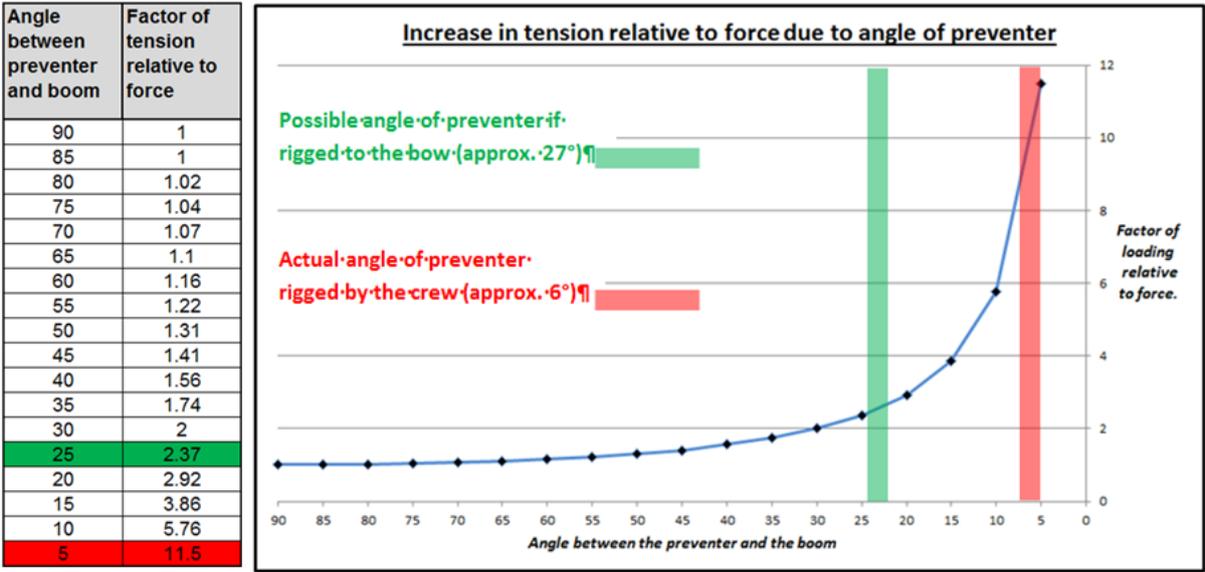
An ideal preventer would be rigged so that the line of the rope is also perpendicular to the line of the boom but on the opposite side to the direction of the force it resists (and the mainsheet). This would provide a one to one ratio, meaning that the load on the preventer rope would be equal to the force acting through the boom at the point the preventer is attached. As the angle between the boom and the preventer is decreased the effect of leverage is increased. This multiplies the load pulling (tension) on the preventer line.

Figure 7 Graph and table indicate the relation between the angle of the preventer rigged from the boom and the resulting force

This graph illustrates how the load pulling on the preventer is inversely proportionate to the angle between the preventer and the boom. The load on the preventer line would be the force (acting

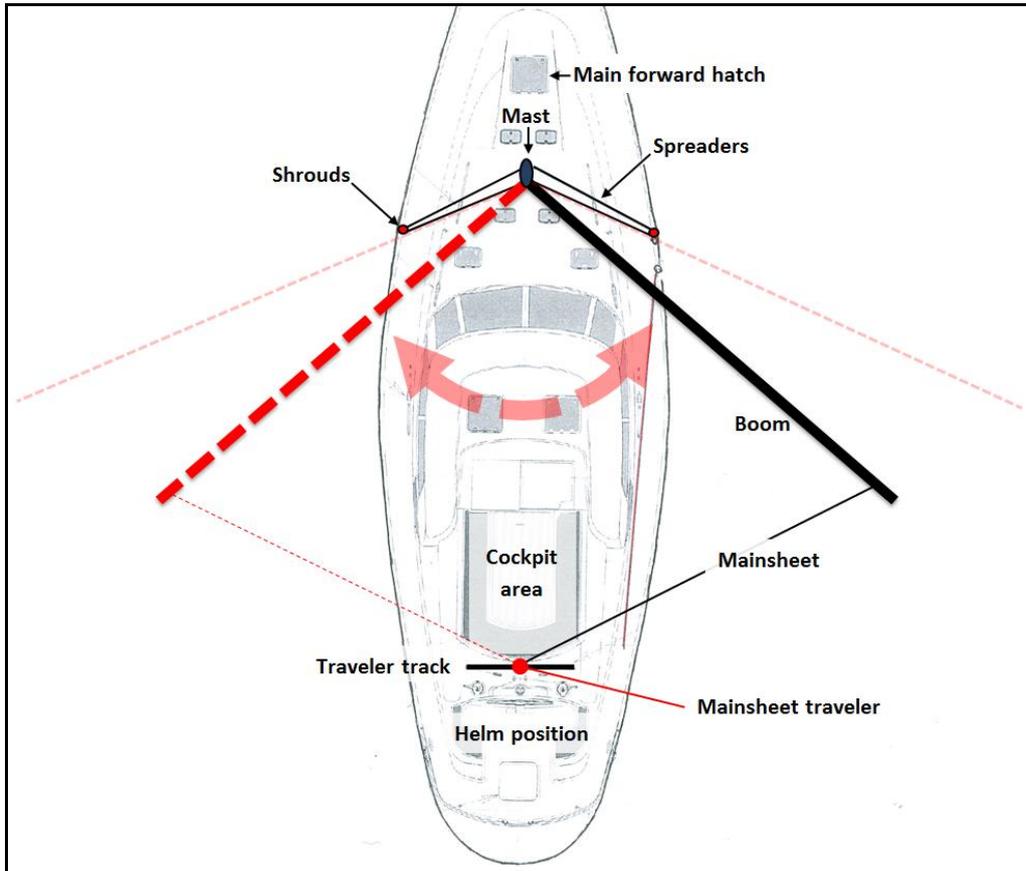
The force of the swinging boom was sufficient to break the mainsheet traveler controller and the traveler car then broke free of the track. The complete failure of the traveler arrangement left the boom swinging from side to side with the mainsheet and traveler hardware hanging from its outboard end. The motion of the boom was now only restricted by the boom hitting the shrouds¹⁰ on either side of the mast.

seating in the cockpit area when the boom was eased out. *Platino's* crew stated the mainsheet traveler was not moved from its central position during the voyage toward Fiji.

Figure 14 *Platino* deck plan drawing showing position of mainsheet traveler
